Lake and Pond Solutions

MD Pellet Program on Viewcrest Channel, Delavan Lake, WI.

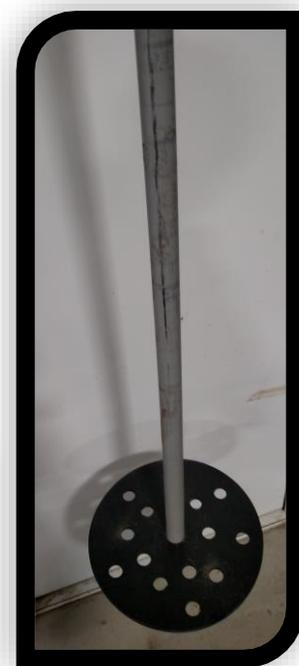
Figure 1: Measuring Pole

The ten-foot pole included marked measurements down to 0.1 feet and included a disk with perforations and o-ring (Figure 1). Once the pole was placed in the water the pole was lowered down to the sediment, the perforated disk would remain on top of the sediment while the pole pushed through to hard-pan refusal. Upon extraction, the disk would fall back into place but the o-ring would remain at the deepest depth reached, indicating the depth of sediment.

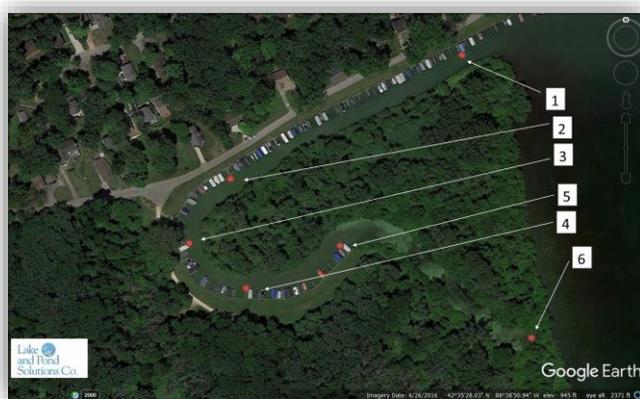
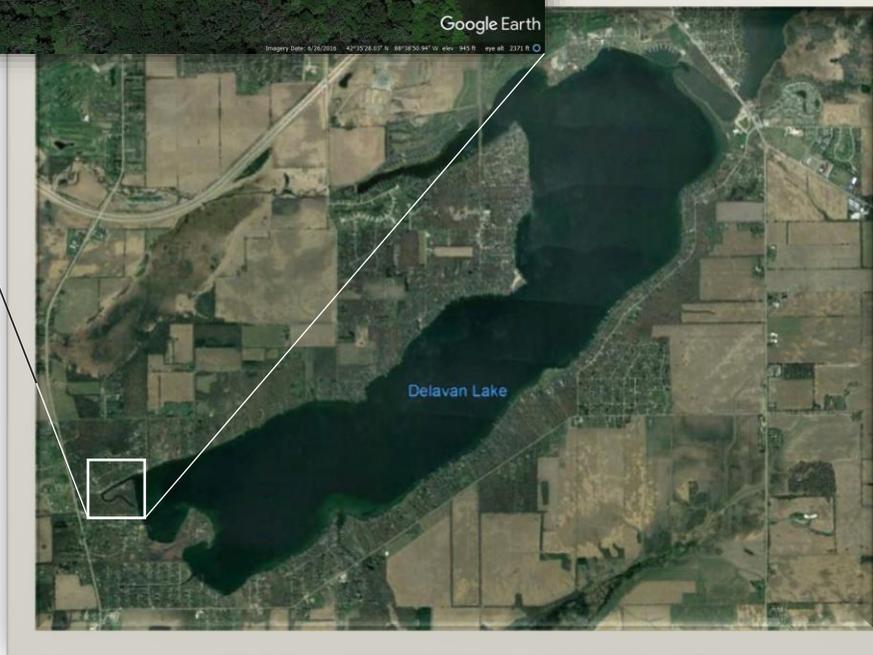
Figure 2: Close up of Viewcrest Channel on Delavan Lake.

The Viewcrest Channel is located on the northern end of Delavan Lake's western bay. See Figure 2 on pg. 2

Before each application a technician measured the water and sediment depth at six locations using a measuring pole. [Locations shown in the top of Figure 2]. The locations were chosen based on proximity to identifiable structures. This was done to maintain a consistent and repeatable measuring area during the following months. A Global-Positioning-Satellite location was also recorded for each location in the event those structures were lost. A sampling site was designated to the beginning and the end of the channel as well as four evenly spaced locations around the curve.

The horseshoe-shaped channel is home to 110+ semi-permanent boat slips. The northern end is open to boat traffic whereas after the last pier on the southern end, it becomes too shallow. However, the back of the channel is connected to the main lake via a three-foot diameter culvert.

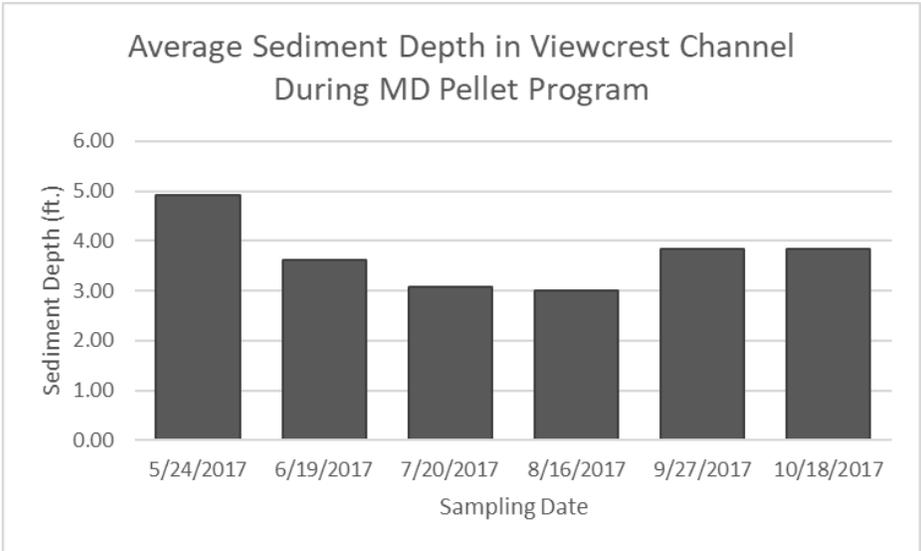
Figure 3: Average sediment depth between each of the six sample points during the monthly survey.

Between the first recording and application on May 24th 2017 and the final recording (one month after the final application) on October 19th 2017 the average sediment depth throughout the channel decreased by 1.08 feet. An average between all six sample points during each sample period is depicted in Figure 3. Figure 4 shows that sediment decreased at each location between these two sampling dates, with the exception of point number 5, where it increased by 0.1 foot. Point 1 saw a 23.4 inch reduction in sediment. Point 2 = 22.2” reduction, Point 3 = 4.2” reduction, Point 4 = 13.2” reduction, and point 6 saw a 15.6” reduction between these sample periods.

The amount of deposited sediment observed over the course of this season has decreased in almost all locations. The slight increases in the fall are likely due to several variables, including rain events and plant senescence. The impact of the July flooding to the channel may have been delayed due to limited inflow and its protected location adjoining a large body of water. With a reduction in sediment comes an increase in average water depth, allowing for better navigation within the channel, its prime function.

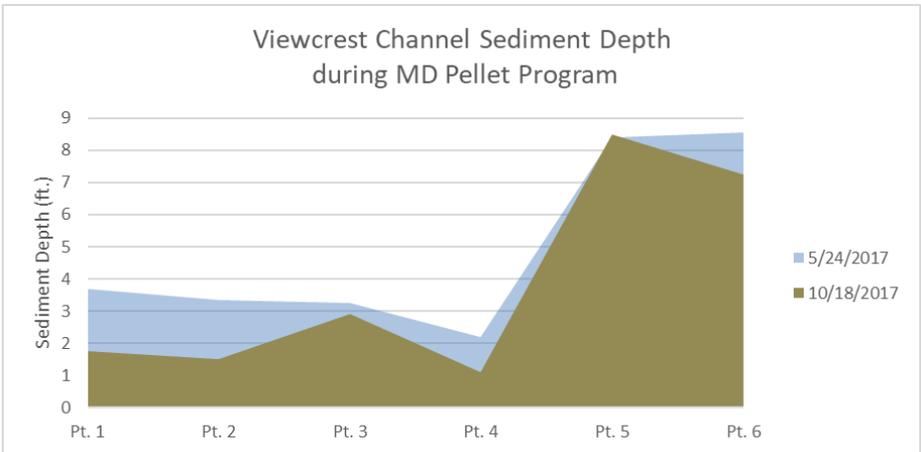
Figure 4: Actual sediment depth of each point during the first and last sample periods. Blue represents May and brown represents October.
