Pond Lily Management Using Cattzilla by Naturalake Biosciences

Ornamental Pond Case Study

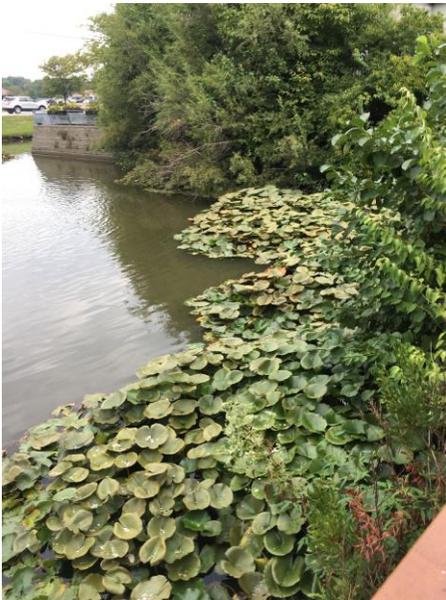
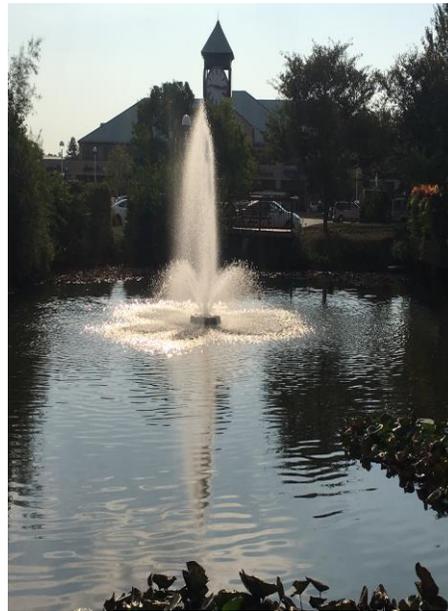
Treatment Zone 1 consists of a continuous lily bed along the west patio and north shore. This zone was treated on 09/11/2019.

The Project area has been divided into three Treatment Zones to be treated progressively until goals are met. Each treatment includes Temperature Driven Solutions Winter Bio and Muck Pellets applied at label rates, followed by contact herbicide solution prepared in a 30 gallon mix tank. For each treatment, the preceding treatment zones are assessed and spot treated for remnant “green” tissue. Cattzilla was added directly to our herbicide application at the rate of 2 gallons per surface acre into the mix tank.

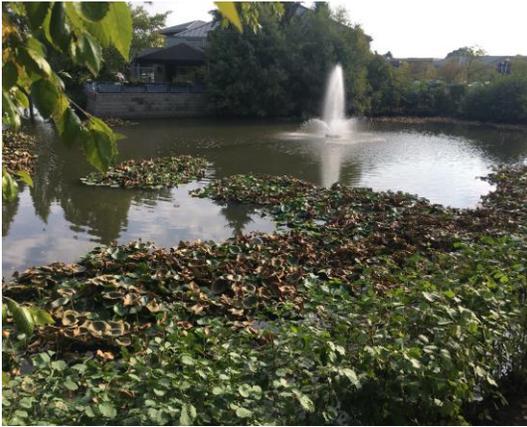
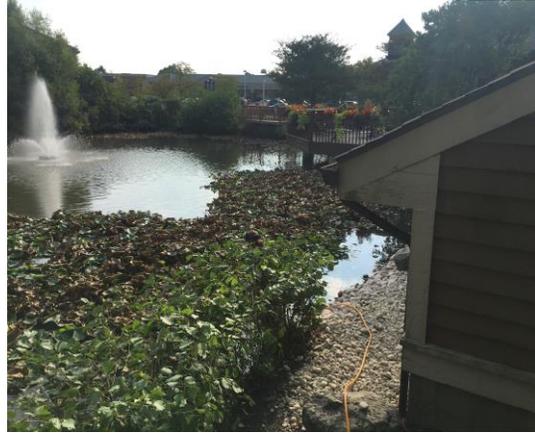
Treatment Zone 2 Stretches out to the center of the pond from the east bank. A portion of this zone is overhung by a dining deck. Zone 2 was treated on 10/1/19.

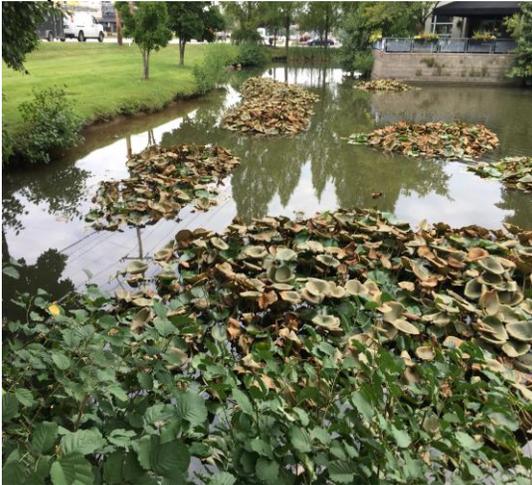
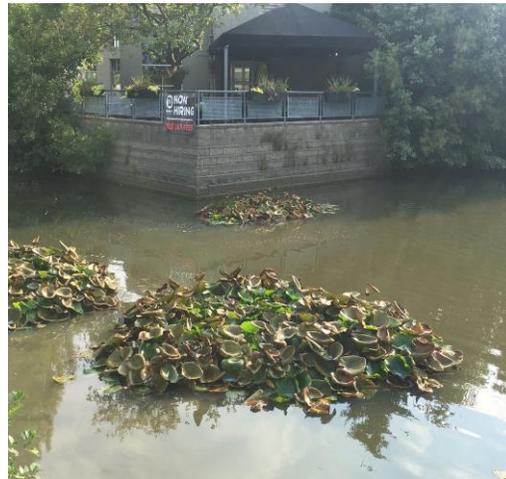
Treatment Zone 3 has multiple smaller beds along the south bank. These beds sit in deeper water than the other beds but are no less dense. Zone 3 was treated on 10/11/19.

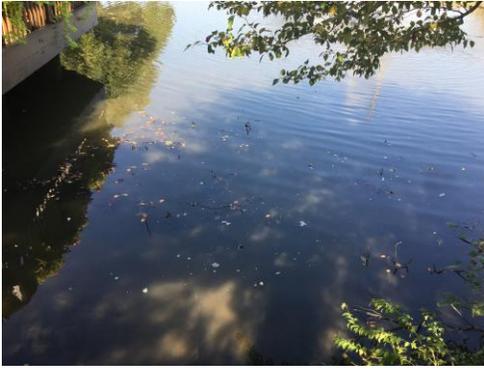
Treatment Zone 1 10/01/19

The treatments met and exceeded or expected results. The first treatment on 09/11/19 achieved a complete defoliation in Treatment Zone 1. The spot treatment on 10/01/19 was applied to stems as they were all that remained of the emergent plant material. Course organic material from the foliage was broken down completely in this zone. Treatment was applied to Treatment Zone 2 on 10/01/19 in the same manner as Treatment Zone 1.

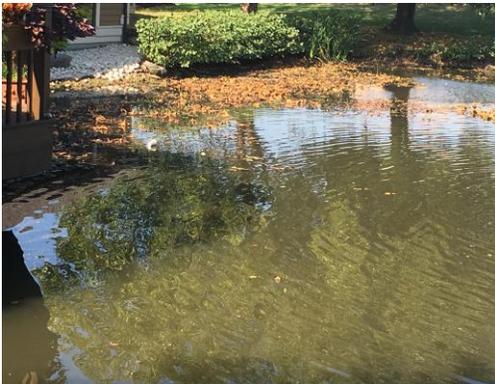
Treatment Zone 2 10/11/19

The final planned treatment took place on 10/11/19 and included a treatment application in Treatment Zone 3 as well as spot treatments in Zones 1 and 2. We found that complete defoliation had been achieved in Treatment Zone 2 in one treatment as well. Treatment Zone 1 was completely clear of emergent plant material and coarse organic material 30 days after the first application. Treatment was applied to Treatment Zone 3 and the few remaining stems in Treatment Zone 2.

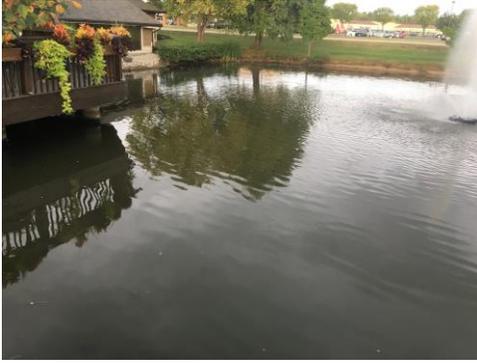
Treatment Zone 1 10/30/19

A follow up site visit and assessment was conducted on 10/30/19. We found that our treatment goals had been achieved. There was no emergent plant material remaining on the margins or across the surface of the pond. No discoloration or stress to aquatic life was evident and the coarse organic material in the pond generally originates from external sources.
