Lake and Pond Solutions Co.

Moon Shadow Pond – Greenville, WI

## **Naturalake Biosciences Case History 2019 – Moon Shadow Pond**

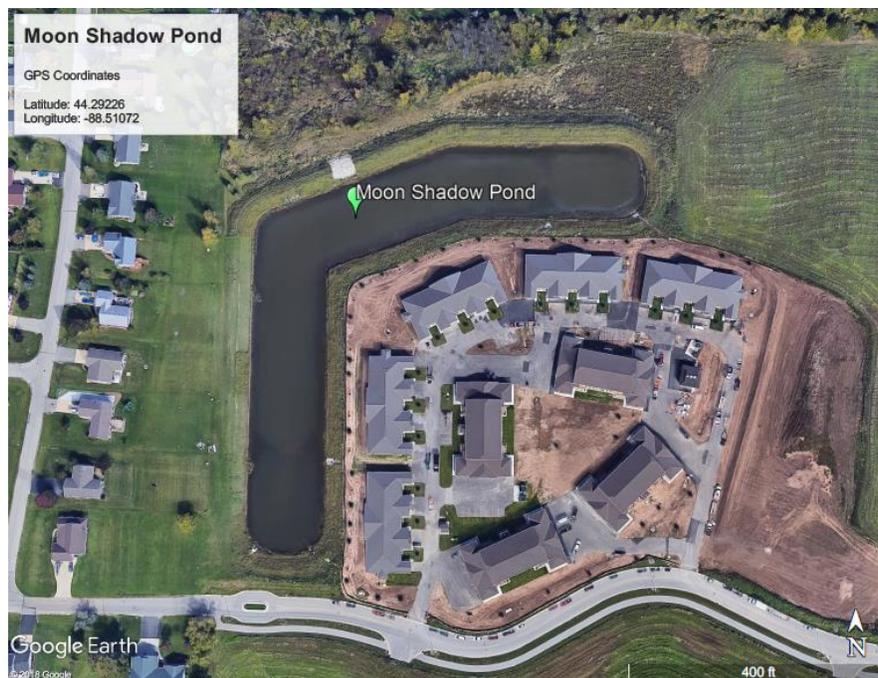
Figure 1. Overview of Moon Shadow Pond (2018).

A qualitative approach to determine the effectiveness of using Pondzilla Pro enzyme along with a copper-based algaecide and a flumioxazin herbicide to treat pithophera and hydrodictyon algae. Treatment site took place at Moon Shadow Pond in Greenville, WI (Figure 1). Moon Shadow Pond is a retention pond that is L shape formation and is adjacent to Moon Shadow Estates apartment complex, 8 houses, and a marsh/field where the outflow of the pond drains into. Significant water runoff from the apartment complex and neighboring community increases its nutrient levels throughout the summer and fall. With high nutrient inflow and heavy runoff accumulation, nuisance algal blooms can be prolific during the growing months. Dense pithophera and hydrodictyon algae growth are common throughout the summer and fall.

The pond was observed in the beginning of August which had roughly 30% of the total surface acreage covered in pithophera and hydrodictyon algae (Figures 1-3). There was an entire perimeter ring of pithophera and hydrodictyon algae mix that extend out an average of 15' with clusters of the mix of algae throughout the entire water surface (Figures 1-3). Our goal was to treat the pond for both types of algae to improve access for recreation and enhance aesthetics. Treating the pond for heavy hydrodictyon and pithophera algae growth required us to treat the entire surface area of the pond to inhibit the regrowth and replication of new algal cells. Along with the initial kill of these cells, we needed long term results. Pondzilla Pro enzyme solution played an important role in aiding the algaecides/herbicide used. Pondzilla Pro enzyme is a catalyst in the reaction between the algae and the algaecides/herbicide mixture. This enzyme solution aids the algaecides and herbicides used by breaking down the plant cell wall and allows for easier and quicker penetration of the herbicide mixture.
