Naturalake Biosciences Case Study 2020 Del Webb at Grande Dunes - Myrtle Beach, SC

INITIAL SURVEY - APRIL 2020

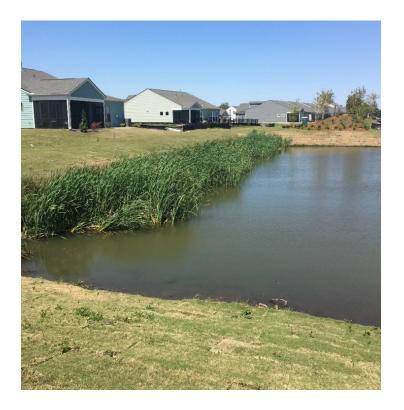
The Lake Doctors, Inc. was contacted to conduct a survey of the stormwater ponds in the Del Webb at Grand Dunes Community in Myrtle Beach, South Carolina. Upon inspection, it was found that one of the stormwater ponds had a severe infestation of cattails and the property manager wanted them gone. The cattails plagued the property manager with two glaring issues;

First, The property manager was routinely getting flooded with phone calls and emails from the residents that live on the storm water pond expressing their concerns with the appearance of the pond with the cattails. Second, the mass of vegetative growth from the cattails completely blocked a stormwater inflow pipe. This hindered the engineered design of the retention pond by decreasing the rate at which the pond could receive runoff from the community streets.

First, utilize select herbicides, surfactants, and CattZilla to kill the cattails initially. Then, utilize select herbicides with PondZilla to treat the remaining growth and degrade the dead biomass. Additionally, add Nature's Blend to the open water to reduce the soluble nutrients released by the cattails.

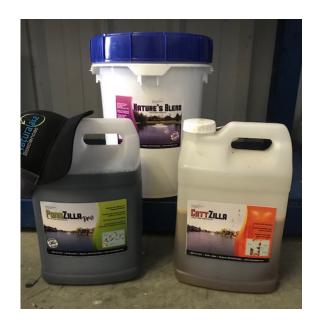
CattZilla, PondZilla, and Nature's Blend were used to eradicate the cattails in three treatments during a span of three and a half months.

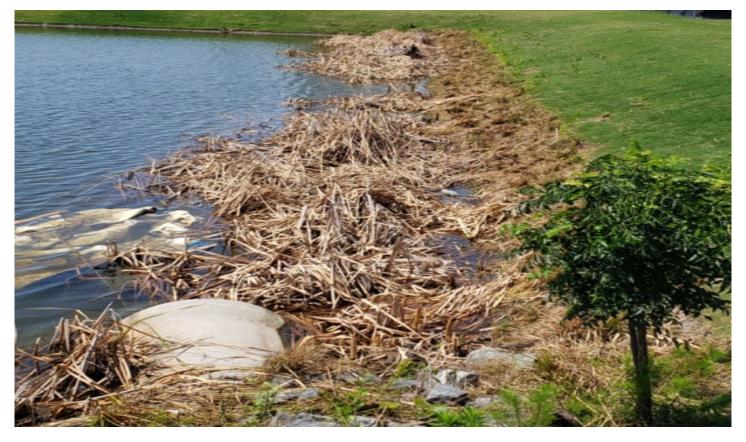
FIRST TREATMENT

Herbicide + CatZilla (1 gal/SA)+ Surfactant on cattails and Nature's Blend (3 lb/SA) into the water body

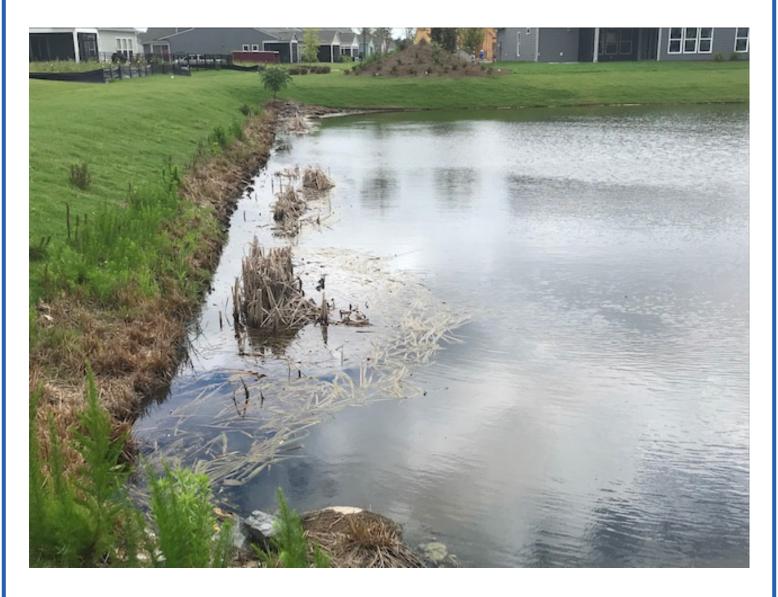
SECOND TREATMENT

Herbicide + PondZilla Pro (1 gal/SA) on cattails and Nature's Blend (3 lb/SA) into the water body

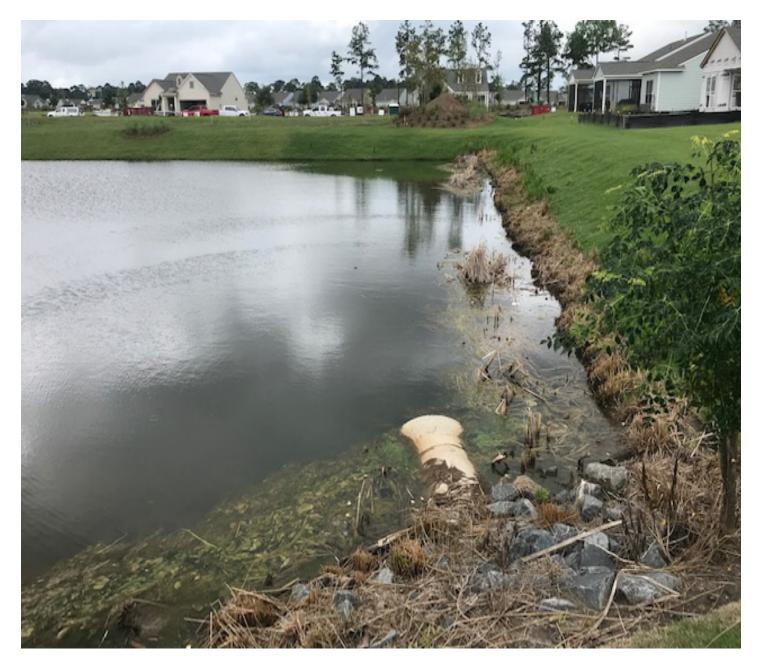
THIRD TREATMENT

Herbicide + PondZilla Pro (1 gal/SA) on cattails and Nature's Blend (3 lb/SA) into the water body

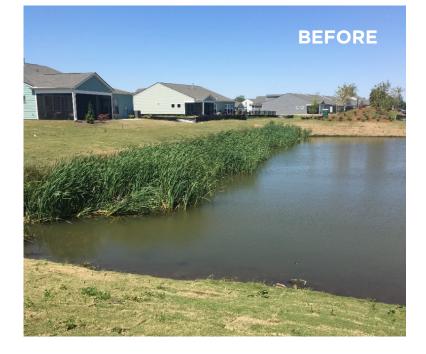
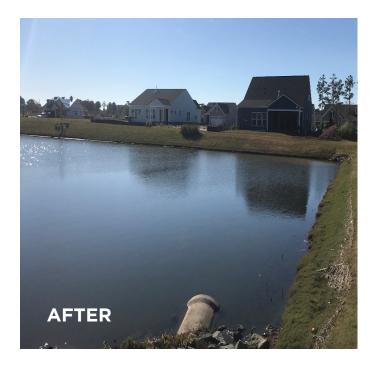
RESULTS

The treatment plan was successful and the storm water pond that is functioning as designed.

Additionally, it is now an aesthetically pleasing storm water pond for the home owners who reside along its waterfront.
